# Manhole Inspection Summary

Manhole # S33I\_\_036MH

Insp Date: **8/13/08 9:48 AM**

**Location** Address: **250 w pratt st**

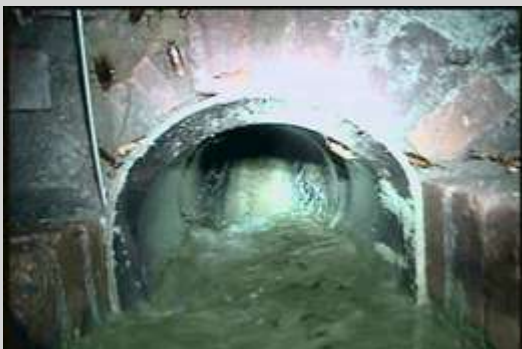
9 O'Clock Inflow

10 in. Circular Gravity Sewer  
Pipe In @ 9 O'Clock

Pipe Height: 0 (in.) Direct

Pipe Material: **Clay** ☐ Pipe Lined

Infiltration: **None** Pipe Seal Cond: **Unknown**
